# Manhole Inspection Summary

Manhole # S27I\_\_025MH

**Inspection** ☐ Is Incomplete Rating: **3) Fair**

**Location** Address: **111 S Schroeder**

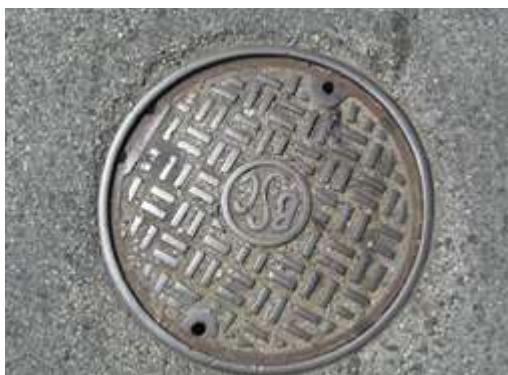
Cover View

Type: **Sanitary** Condition: **Worn** Cover Material: **Cast Iron**

**Frame** Offset: **0** (in.) Condition: ☐ Sound ☐ Cracked ☒ **Leaks**

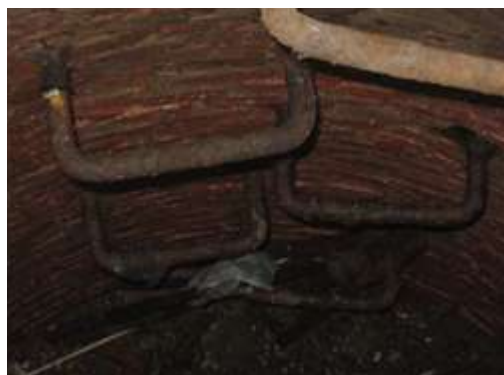
Defect 4

**Steps** Count: **8** Missing: **0** ☒ **Corroded**

corroded steps

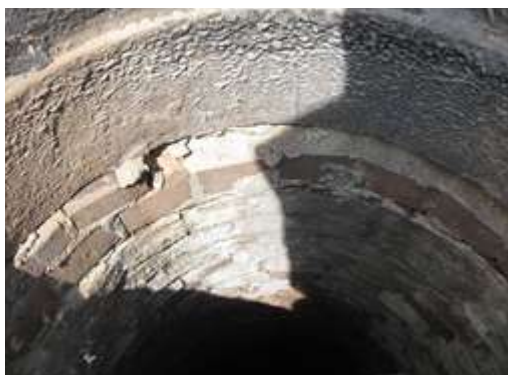
Defect 3

Condition: ☐ Sound ☐ Cracked ☐ Root Intrusion ☒ **Loose Brick** ☒ **Deteriorated**

Infiltration: ☐ None ☐ Joint ☐ Cracks ☒ **Mortar** ☐ Roots ☒ **Wall**

chimney mortar, chimney flow wall,  
chimney cond deteriorated

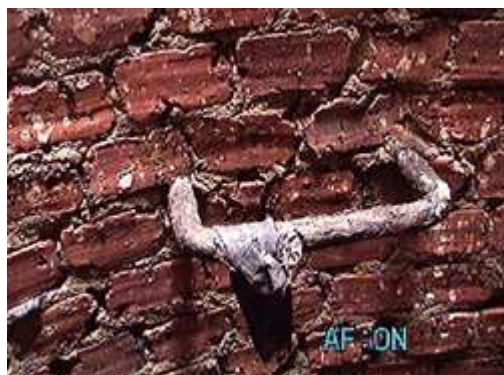
Defect 2

**Surcharge** ☒ **Evidence Of Surcharge** Depth: **7** (ft.) ☐ Active Surcharge Present

evidence of surcharge

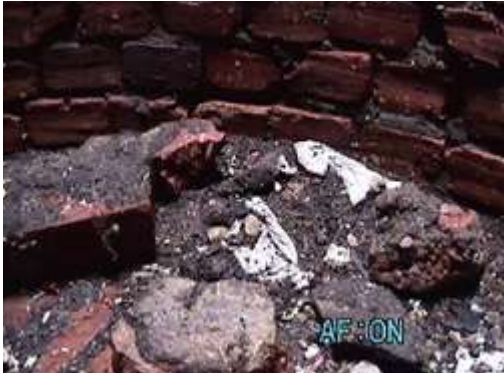
### Defect 1

Condition: ☐ Sound ☐ Cracked ☐ Root Intrusion ☐ Deteriorated ☐ Leaks ☒ **Debris**

bench cond debris
